Docket No. 217 – Development and Management Plan Inspection

Northeast Utilities Service Company Certificate of Environmental Compatibility and Public Need for the construction of a 345-kV electric transmission line and reconstruction of an existing 115-kV electric transmission line between Connecticut Light and Power Company's Plumtree Substation in Bethel, through the towns of Redding, Weston, and Wilton, and to the Norwalk Substation in Norwalk, Connecticut.

Date: October 25, 2006

Location: Transition Stations: Hoyts Hill, Archers Lane, Norwalk Junction

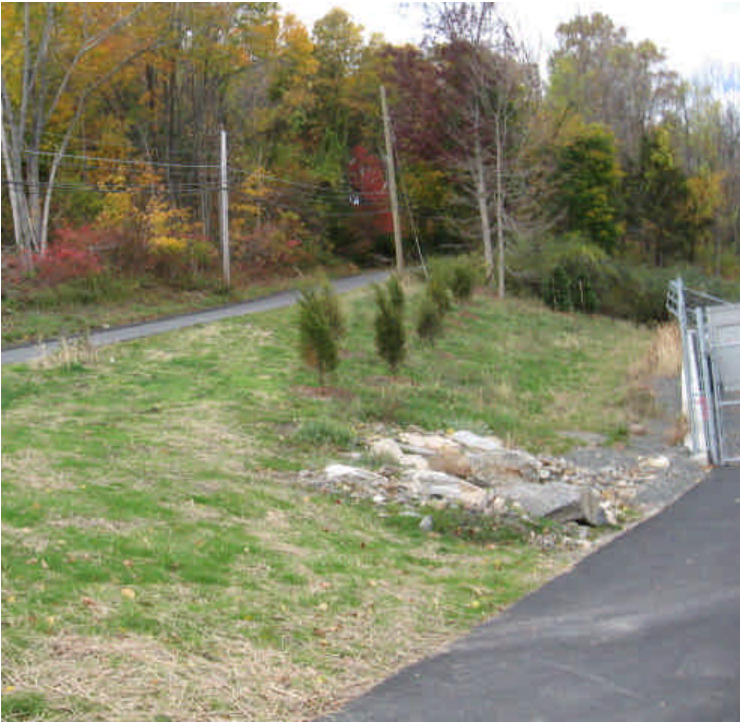
Hoyts Hill: Photo on the left shows the western slope which is well restored with sufficient grass cover. Photo on the right shows the well restored wetland area. Silt fence could be removed at any time. 10/25/06.

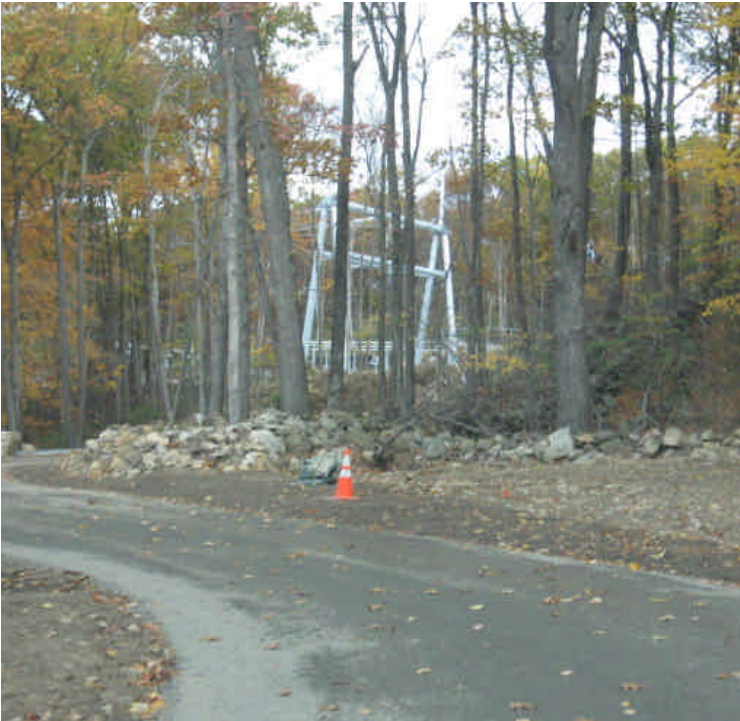
Archers Lane: Photo on the left shows the sub-base installed on the driveway with the adjacent area graded out. Stockpiles had been removed. Photo on the right shows haybales installed at the outlets of the waterbars as recommended. 10/25/06.

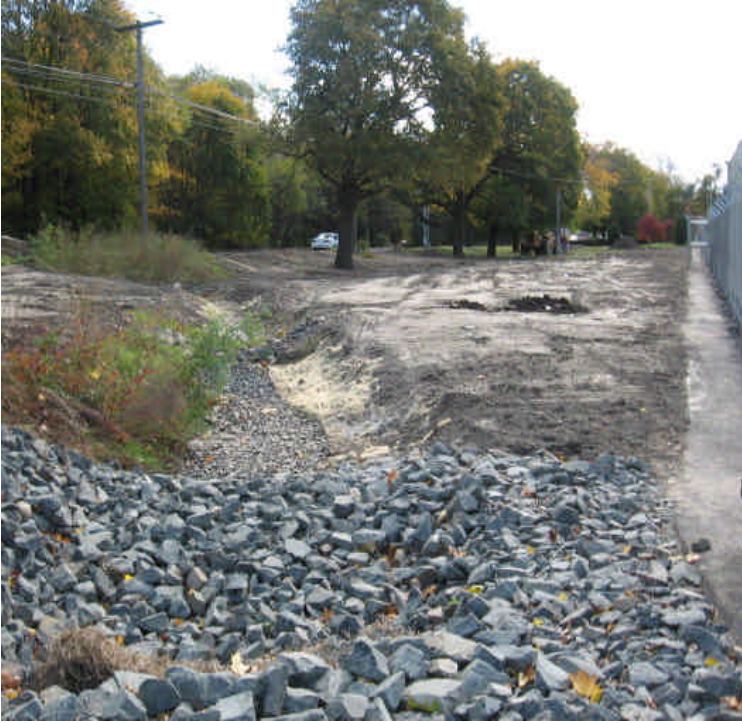
Norwalk Junction: Photo on the left shows where the disturbed area near Rt 7 has been graded and loamed. Mulch should be spread on the entire area in an effort to stabilize it temporarily before the winter. Photo on the right shows stockpiles of landscaping materials. These were being planted at the time of inspection. 10/25/06.

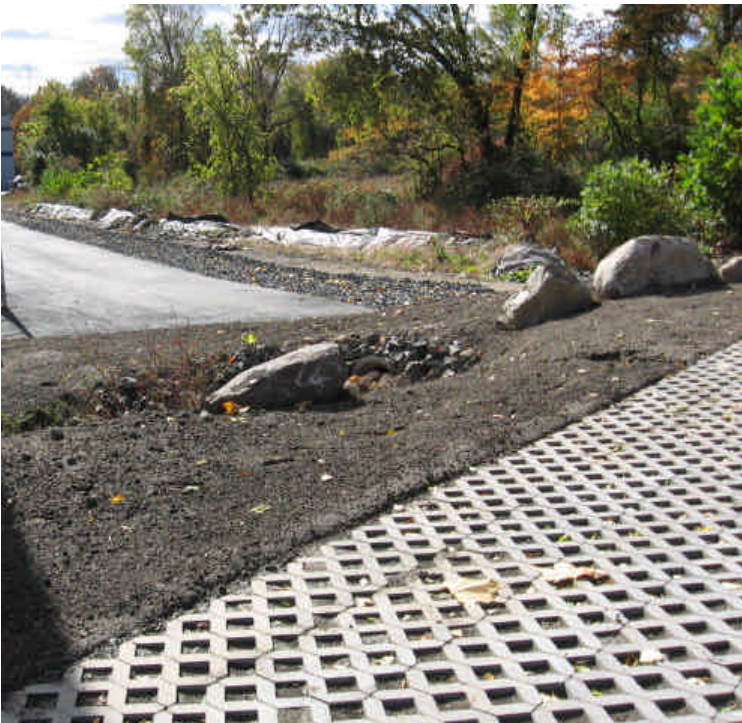
Photo on the left shows the loamed areas adjacent to the pervious along the slopes of the swale. Photo on the right shows a washout that has occurred in the recently installed loam on the slope of the swale. 10/25/06.
